## Condition Assessment and Recommended Interventions for the Sungai Pegoh Rural Bridge Using the Bridge Management System (BMS) Method

**Table 1. Technical Characteristics of the Sungai Pegéh Bridge**

**Table 2. Condition Assessment of the Sungai Pegéh Bridge Based on the BMS Method**

**Table 3. Damage Analysis of Individual Elements of the Sungai Pegéh Bridge**

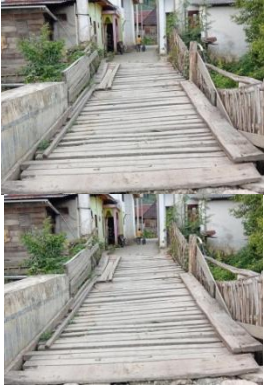
| No. | Bridge Element | Type of Damage | Damage Extent | Condition Rating (CR) | Condition Category |
|---|---|---|---|---|---|
| 1 | Bridge Approach | Landslide caused by river overflow | 40 m <sup>3</sup> | 4 | Severe Damage |

| No. | Field Documentation | Element | Condition and Analysis |
|---|---|---|---|
| 1 | | Bridge Approach | The inspection results showed that the bridge approach experienced a landslide with an estimated volume of approximately 40 m <sup>3</sup> due to river overflow during the rainy season. This damage may disrupt vehicle accessibility and reduce the serviceability of the bridge. According to BMS (1993), damage to the bridge approach area should be addressed promptly because it may develop into localized structural failure. Therefore, reconstruction of the embankment and installation of gabions are recommended to protect the riverbank and stabilize the approach area. |

| No. | Bridge Element | Type of Damage | Priority Level | Recommended Intervention |
|---|---|---|---|---|
| 1 | Bridge Approach / Road Connection | Landslide | Very High | Reconstruction of the embankment, soil compaction, and installation of gabions or stone masonry for slope and riverbank protection. |

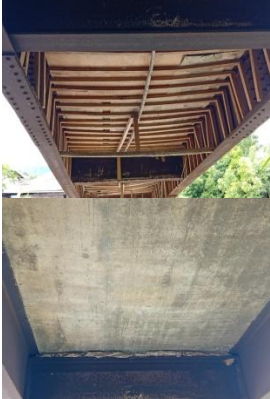
| No. | Bridge Element | Type of Damage | Damage Extent | Condition Rating (CR) | Condition Category |
|---|---|---|---|---|---|
| 3 | Bridge Deck Slab | No significant damage identified | – | 0 | Good |

| No. | Field Documentation | Element | Condition and Analysis |
|---|---|---|---|
| 3 | | Bridge Deck Slab | The bridge deck slab showed no signs of cracking, deformation, or surface delamination. This condition indicates that the deck element remains capable of performing its intended function adequately. |

| No. | Bridge Element | Type of Damage | Priority Level | Recommended Intervention |
|---|---|---|---|---|
| 7 | Bridge Deck Slab | No Significant Damage Identified | Low | Routine maintenance and periodic inspection. |

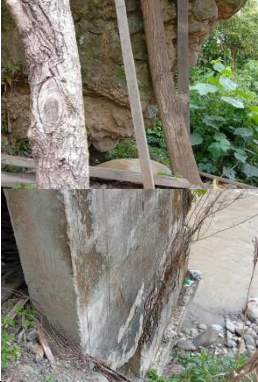
| No. | Bridge Element | Type of Damage | Damage Extent | Condition Rating (CR) | Condition Category |
|---|---|---|---|---|---|
| 5 | Abutment | Concrete breakage at the upper and lower sections | 0.8 m <sup>3</sup> | 4 | Severe Damage |

| 5 | | Abutment | Damage in the form of concrete spalling and breakage was observed at the upper and lower sections of the abutment, with an estimated volume of approximately 0.8 m <sup>3</sup> . The deterioration is suspected to be influenced by river scour and lateral earth pressure around the structure. As the abutment is a primary structural component, rehabilitation and structural strengthening are required to prevent further reduction in bridge stability. |

| No. | Bridge Element | Type of Damage | Priority Level | Recommended Intervention |
|---|---|---|---|---|
| 2 | Abutment | Damage at the upper and lower sections | Very High | Structural rehabilitation, repair of damaged concrete, and strengthening of the foundation area. |

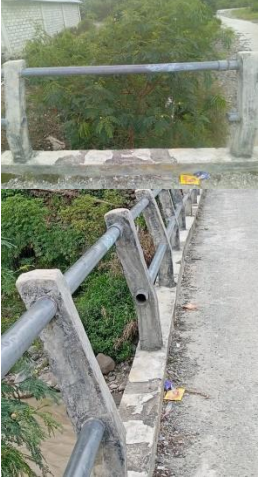
| No. | Bridge Element | Type of Damage | Damage Extent | Condition Rating (CR) | Condition Category |
|---|---|---|---|---|---|
| 6 | Horizontal Railing Member | Missing / Detached | 1 unit | 2 | Moderate Damage |

| 6 | | Horizontal Railing Member | One horizontal railing member was found to be missing or detached. Although this condition does not affect the load-carrying capacity of the main bridge structure, it may reduce user safety. Therefore, replacement of the missing element is recommended. |

| No. | Bridge Element | Type of Damage | Priority Level | Recommended Intervention |
|---|---|---|---|---|
| 4 | Horizontal Railing Member | Missing / Detached | Moderate | Replacement and reinstallation of the missing railing element. |
